PORTSMOUTH CIVIC CENTER

PACE Collaborative, P.C.

PACE Project #19050
April 17, 2019

CONDITION ASSESSMENT

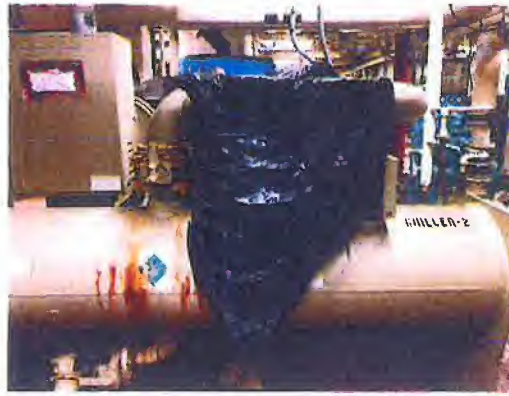
At the time of the visit the chiller was not operational. Oil pressure alarm was on the chiller control screen. The chiller has reached its expected service life of 25 years.

Chiller appears to be in poor condition.

Have the chiller serviced and repaired. Plans should be made to replace the chiller in the near future.

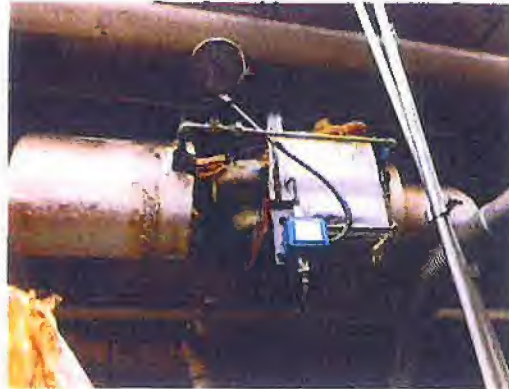
Chiller 2 circulating pumps (located directly above the chiller)

Primary chilled water pump above C-2 appears to be in poor shape. Visible leaks, uninsulated and corroded.

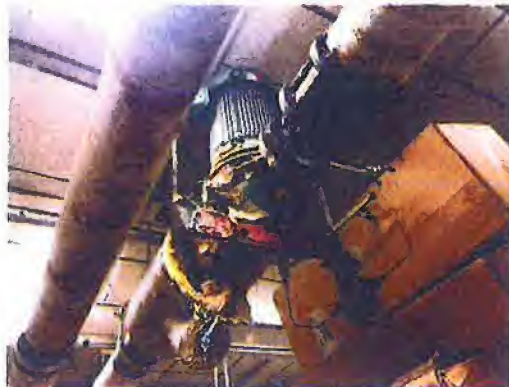
Pump serving the Jail building

Dual Temperature pump serving the jail motor has bad bearings (very noisy operation), is very badly corroded and has visible leaks.

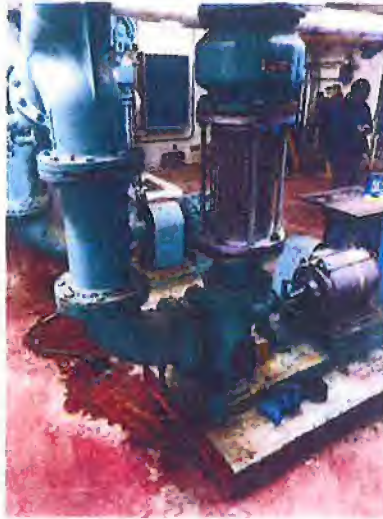
Disassembled Pump P-1

Hot water pumps, both show signs of leaks and corrosion. Exact age is not known but they appear to be over 20 years old. Expected service life for this type of equipment is 20 years. One of the pumps (P-1) was disassembled during the site visit. Both pumps are in poor condition and should be replaced.

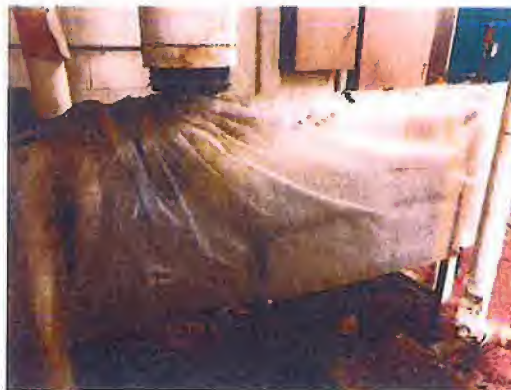
Domestic hot water heat exchanger is covered with plastic to protect it from water leaks through building expansion joints. It appears to be operational but not in a good condition. Recommend eliminating it once it fails, and installing a new domestic hot water heating system, which would also eliminate the need to run a very large heating hot boiler in the summer to provide domestic hot water.

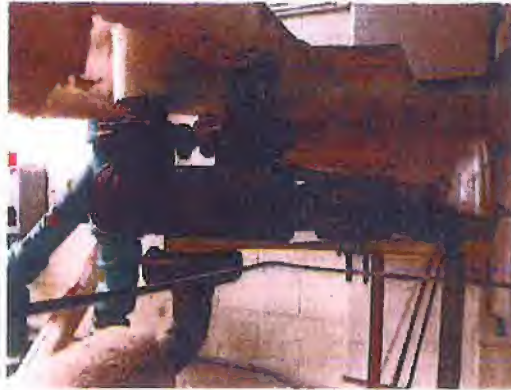
Dual temperature switch over valves do not function and the switch over from heating to cooling needs to be done manually. The valve non-functioning pneumatic actuator is being held together by a strap. When the system is switched over, according to maintenance personnel, it causes relief valves to open due to differential in two system pressures.

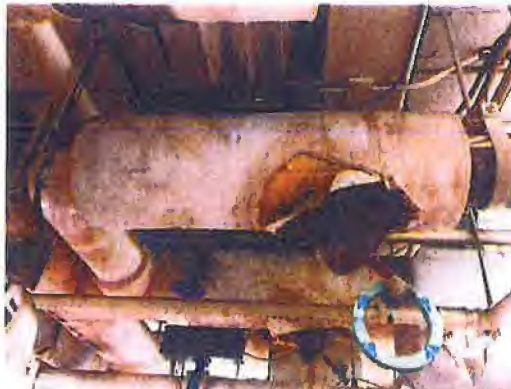
Original isolation valves that are still in place are badly rusted and the handles tend to break off when operation is attempted.

Other piping accessories that have not been recently replaced are severely corroded, indicating elevated moisture, and humidity levels in the mechanical room.

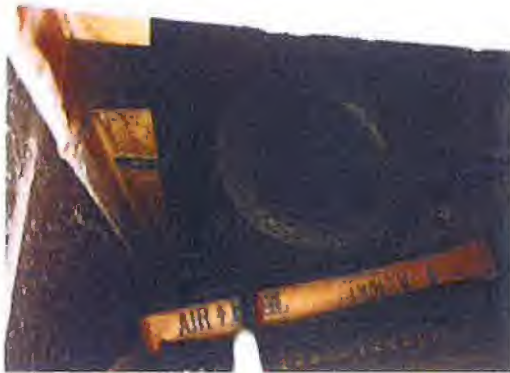
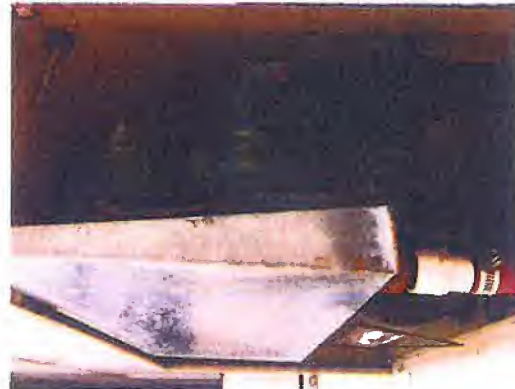
Basement Fancoil Units

Fan coils in the basement appear to be original to building construction and are in bad shape. Most do not function and are in disrepair. Filters are dirty and have not been replaced in some time, control valves are not functioning, and some of the access panels are missing.

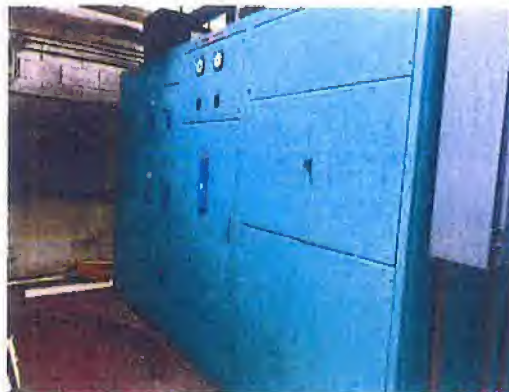
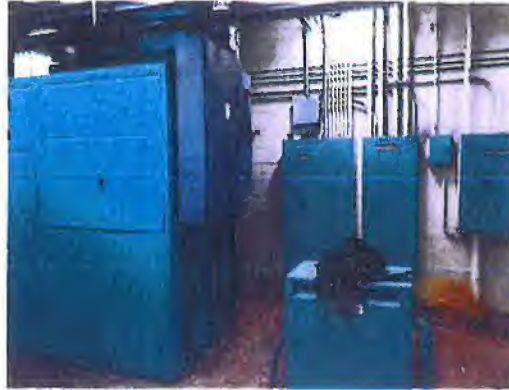
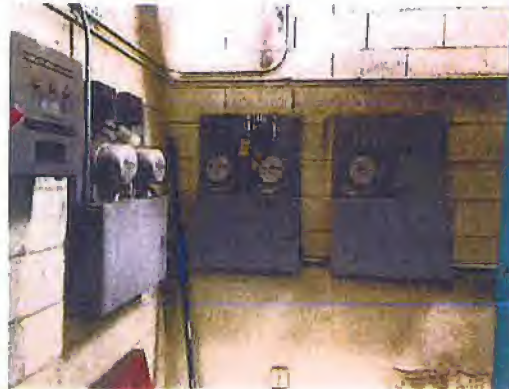
There are additional fusible switches tapped off the bus for additional feeders because of obsolete switchboard and no available space for additional breakers.

The switchboard and busway appear to be original to the building and is approximately 49 years old. The switchboard and busway are obsolete, and replacement parts would be very difficult to obtain. The switchboard is beyond the expected useful life of 30 years according to the "Building Owners and Managers Association" (BOMA).

Based on the condition and age of the switchboard, replacement is recommended.

In addition, we recommend that the service and transformer be relocated to a higher elevation to eliminate the potential for flooding.

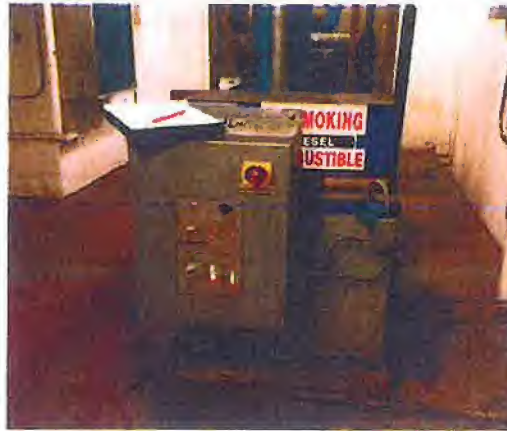
Each generator has its own day tank with associated simplex fuel supply pump and supply piping. There is no return piping or return pump.

The fuel system to the day tank does not have a return line and return pump to keep the day tank from overflowing in the event that the supply pump did not shut off when called for as recommended by NFPA 31.

We also recommend that the day tanks be replaced with a duplex pump arrangement so that it has a supply pump and a return pump as required by the NFPA 31.

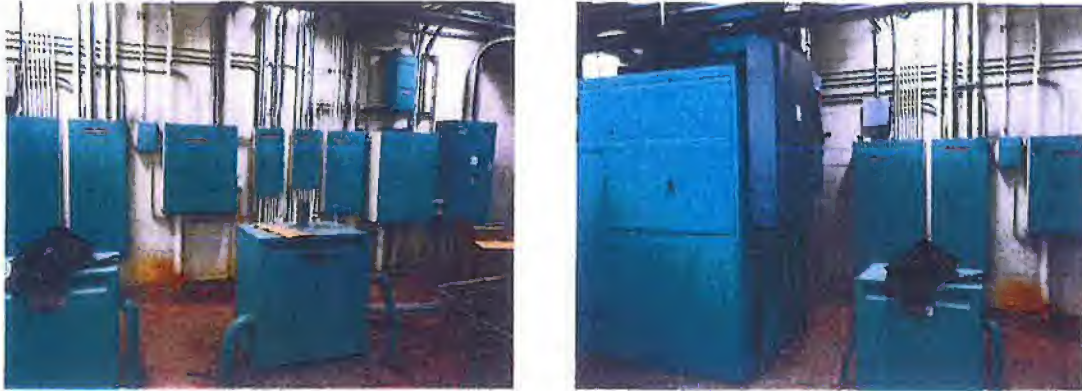
The panelboards, motor control center and dry type transformers appear to be original to the building and are approximately 49 years old. The panelboards and motor control center are obsolete, and replacement parts would be very difficult to obtain. These items are beyond the expected useful life of 30 years according to the "Building Owners and Managers Association" (BOMA).

Based on the condition and age of the panelboards, motor control center and transformers replacement is recommended.

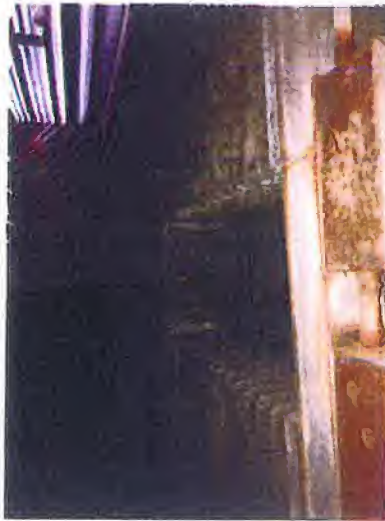
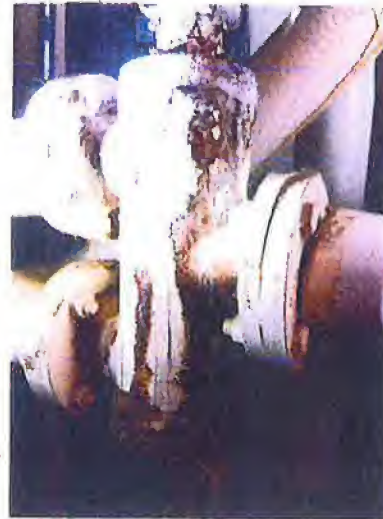
Unit is utilizing an electrostatic filter system, which does not appear to be functional, has missing filter modules from the rack, loose belts on the fans, debris built up on the coil, control valve does not modulate and leaks, coil is not accessible for proper cleaning or service.

Unit should be replaced with a more traditional and standard air handling unit.

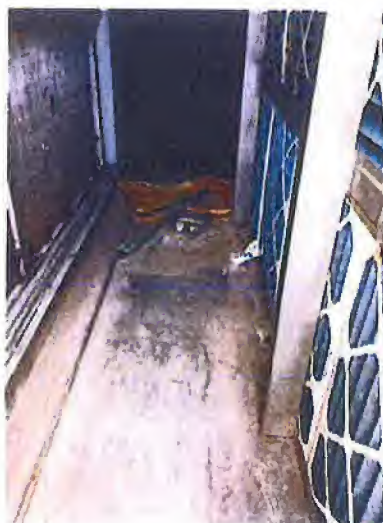
Very poor access to filter section. Filters need to be replaced. There is debris within the unit cabinet, fan belt is loose, drain pan is severely rusted, condensate drain line is broken, visible leak in the hot water heating line.

Debris in unit cabinet.

Unit should be serviced, cleaned and repaired. With proper maintenance, the unit should have another 5 years of service left.

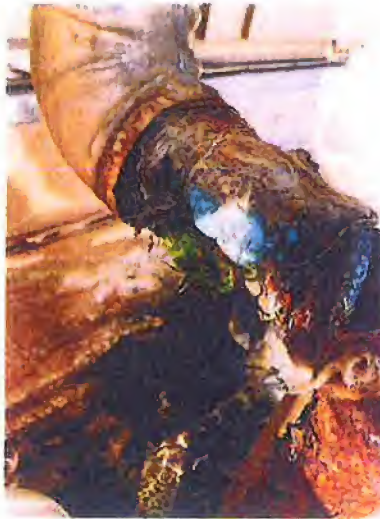
Water leak through a split shut off valve.

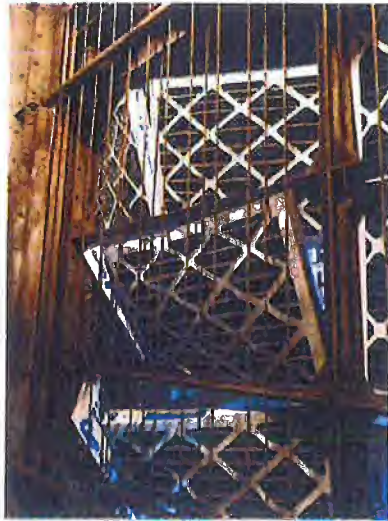
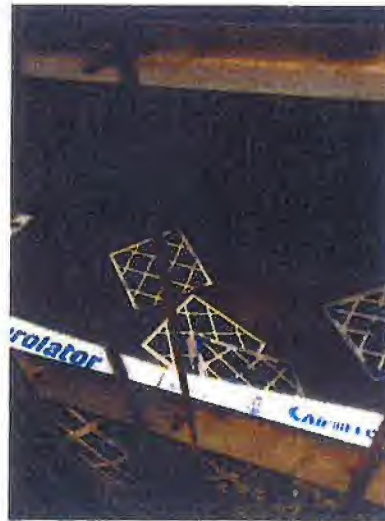
Unit used to utilize an electrostatic filter system, which has been disconnected and regular pleated filters are being used. Multiple filters are out of the tracks, some have been pulled out of the track by airflow due to debris built up. Unit has loose belts on the fans, debris built up on the coil, control valve does not modulate and leaks, coil is not accessible for proper cleaning or service.

Filters out of track

Unit should be replaced with a more traditional and standard air handling unit.

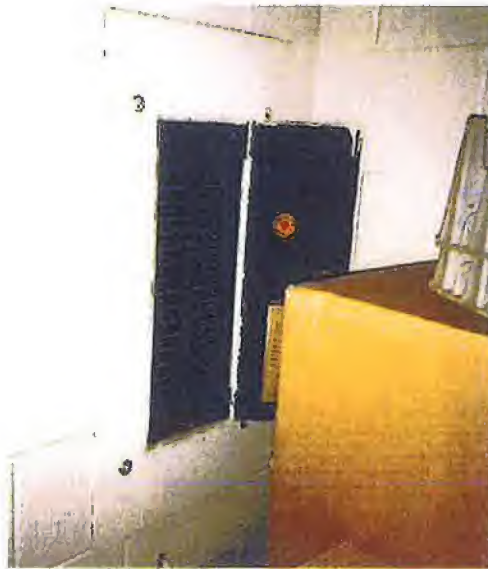
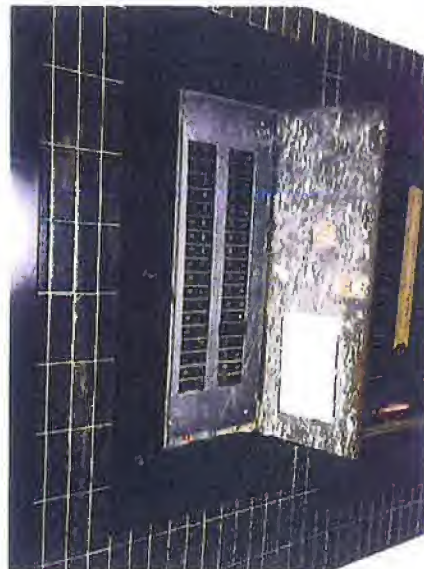
The panelboards, and dry type transformers appears to be original to the building and are approximately 49 years old. The panelboards are obsolete and replacement parts would be very difficult to obtain. These items are beyond the expected useful life of 30 years according to the "Building Owners and Managers Association (BOMA).

Based on the condition and age of the panelboards, transformer replacement is recommended.

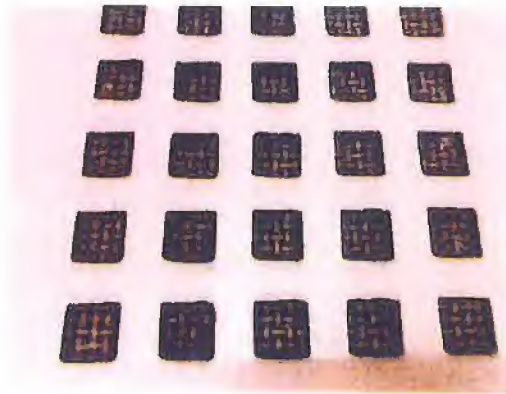
EF-1 was operational but is in poor shape due to age of equipment. It has surpassed it's service life and plans should be made to replace it in the near future. EF-2 has been replaced and is only 5 years old, with proper maintenance it should last another 15 years. Exhaust ductwork and grilles appear dirty and should be cleaned. Exhaust grilles have been painted multiple times over the years which caused a reduction in the open areas of the grilles, which are also clogged up with dust and debris affecting their performance.

Clogged Exhaust Grilles

Based on the condition and age of EF-1, we recommend replacing the fan. Exhaust ductwork should be cleaned and the exhaust grilles should be replaced.

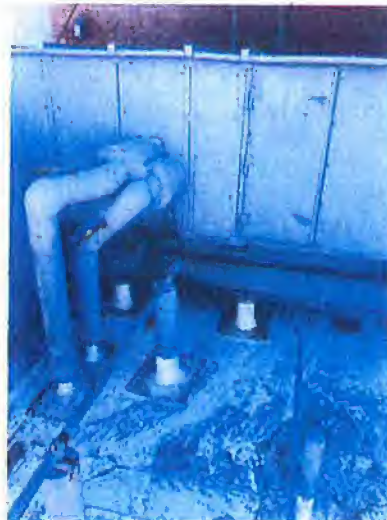
Make-up air is provided by two roof mounted units. Age of the equipment could not be determined due to missing name tags, but they appear to be original to the installation. They appear to be functioning but are in poor shape due to age and exposure to the elements.

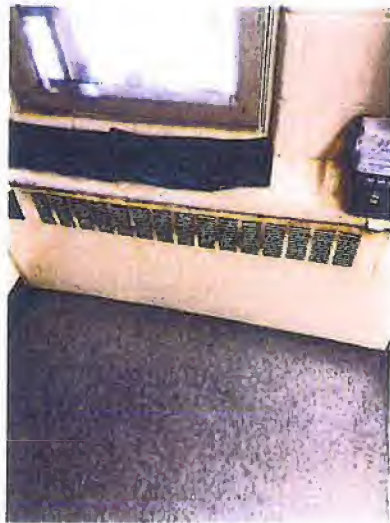
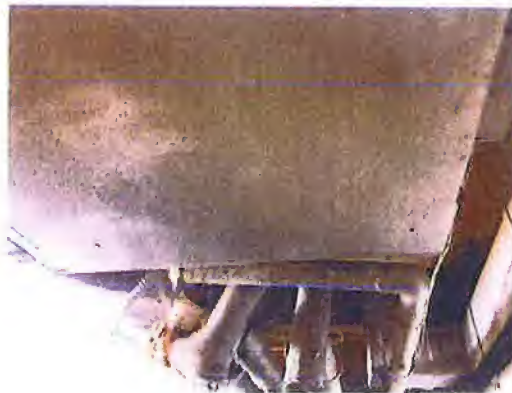
Fan coils appear to be in poor shape. According to maintenance the 3-way control valves are non-functioning, so units operate on/off instead of modulating. Coil piping accessories are in poor condition.

Fan Coil Units.

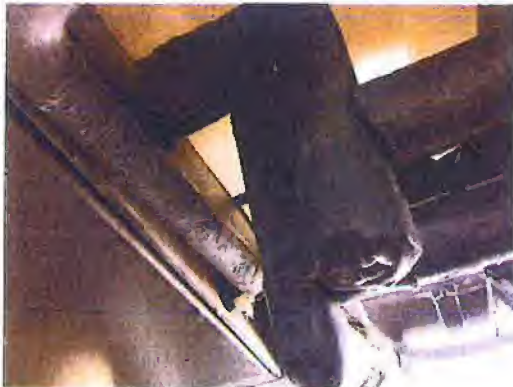
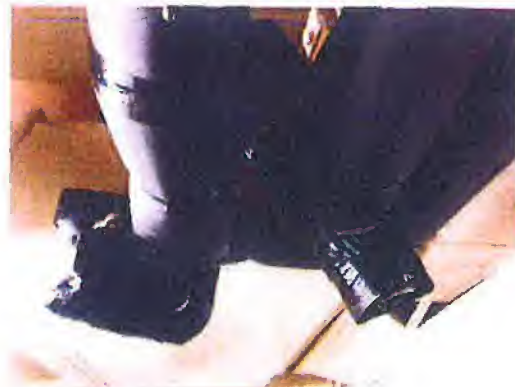
Piping within the building is original and is over 40 years old. Insulation is starting to fail, reducing the efficiency of the system. Some insulation has been patched and reinsulated, but improperly over top of original insulation.
